DELAWARE RIVER BASIN
TROUT BROOK, SUSSEX COUNTY
NEW JERSEY

N. J. NO NAME
DAM NO. 36

NJ 00532

PHASE 1 INSPECTION REPORT
NATIONAL DAM SAFETY PROGRAM

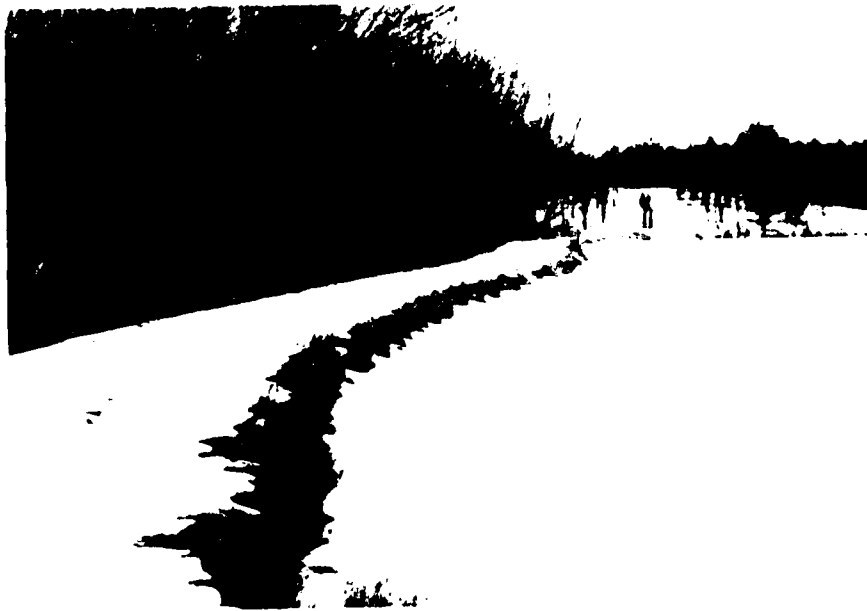
The crest of the dam appeared to be generally evenly graded although evidence of vehicle wheel ruts were observed. The crest and upstream face of the dam were grass covered with a few small trees located on the upstream face. There appeared to be some riprap located on the upstream face of the dam, but detailed observation was not possible due to the presence of ice and snow.

PHOTO 5
UPSTREAM FACE AND CREST OF EMBANKMENT

- 1) The outlet works should be restored to operational adequacy.
- 2) Cracked concrete of the spillway headwall should be repaired.
- 3) Eroded areas along the upstream face of the dam should be filled and stabilized.

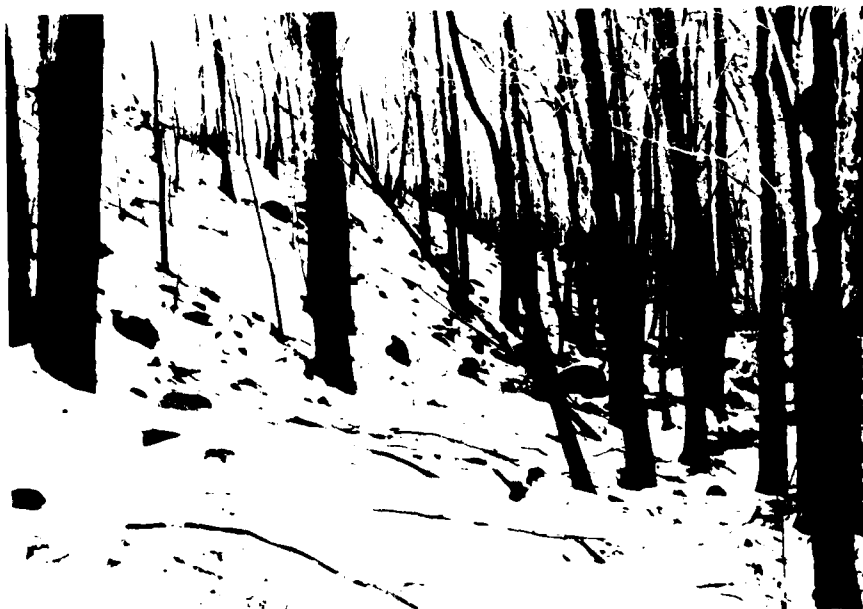
appeared to have a slope of 1 horizontal to 1 vertical. At at least two locations, the face was bulged out in relation to adjoining areas of the embankment. One bulge measured approximately 15 feet across and about 10 to 12 feet high. It protruded from the line of the downstream side of the embankment by approximately 2 to 3 feet. At the toe of the bulge, a spot which was wet and contained orange deposits indicating possible seepage was observed. Trout Brook which flows along a portion of the downstream side of the dam, was observed to lie very close to the dam at the point of the bulge.

The right abutment of the dam which is natural earth appeared to be in satisfactory condition. The emergency spillway at the left end of the dam appeared to have been cut into original soil. The downstream side of the dam near the left end appeared to be more irregularly shaped and more thickly overgrown with trees, weeds and briars than the remaining portions.

PHOTO 6
DOWNSTREAM FACE OF EMBANKMENT

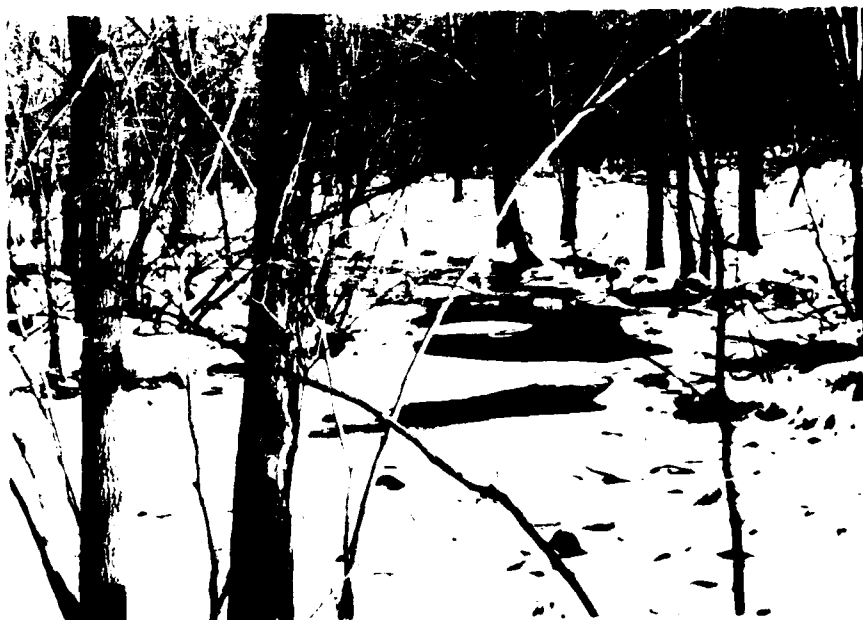
VISUAL EXAMINATION OF	OBSERVATIONS	REMARKS OR RECOMMENDATIONS
CONDITION (OBSTRUCTION, DEBRIS, ETC.)	Downstream channel flows approx. parallel to dam about 20' from toe. Spillway discharges into downstream channel by discharge channel. Downstream channel consists of wide natural stream with cobble-lined bed.	Dam is off-stream.
SLOPES	Banks approx. 2' high with moderate to steep wooded terrain beyond the banks.	
STRUCTURES ALONG BANKS	Small dam located 1100 feet downstream of dam. Two dwellings and road bridge located 1200 feet downstream of dam. Dwellings 6 feet above streambed.

PHOTO 8
DOWNSTREAM CHANNEL
